# Building Inspection Report

2150 N Cormack Dr Brookfield, WI 53005

3/3/2025

CS500126

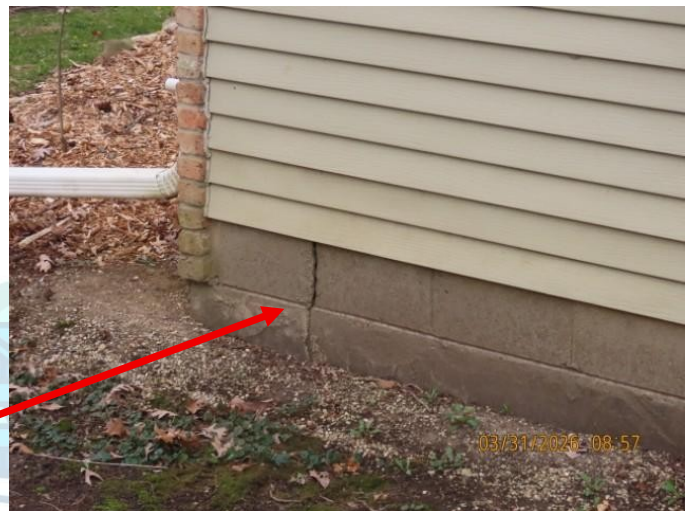
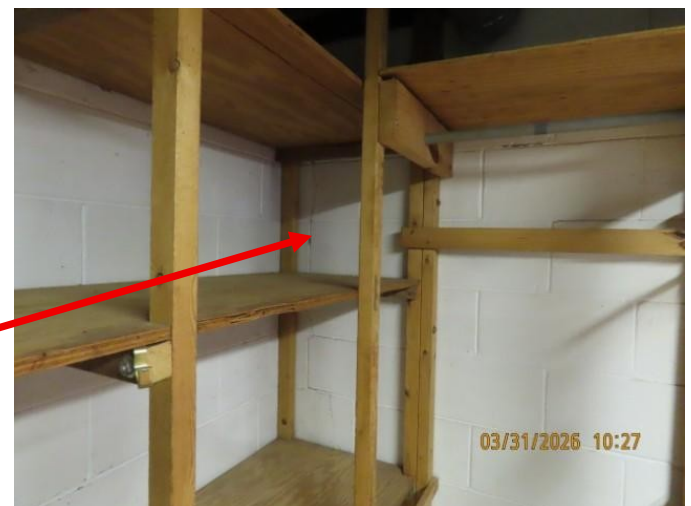
- Defect:** Substantial foundation settlement cracking and lateral displacement was observed on the north wall from the exterior at a corner. Structural movement of the building has occurred. Since repairs may be needed to protect the building from more serious damage, a structural engineer who is familiar with foundation repair or a company specializing in foundation repairs should be consulted to evaluate the condition and to suggest corrective measures. The rate of movement cannot be predicted during a one-time inspection. These cracks may need sealing on the exterior to prevent moisture penetration. Recommend removing interior basement finishes so that the wall can be properly evaluated. (Structure)

- Defect:** Substantial foundation settlement cracking and lateral displacement was observed on the South Foundation wall as viewed from the interior of the basement. This displacement is less than the north wall but needs evaluation. Structural movement of the building has occurred. Since repairs may be needed to protect the building from more serious damage, a structural engineer who is familiar with foundation repair or a company specializing in foundation repairs should be consulted to evaluate the condition and to suggest corrective measures. The rate of movement cannot be predicted during a one-time inspection. These cracks may need sealing on the exterior to prevent moisture penetration. (Structure)

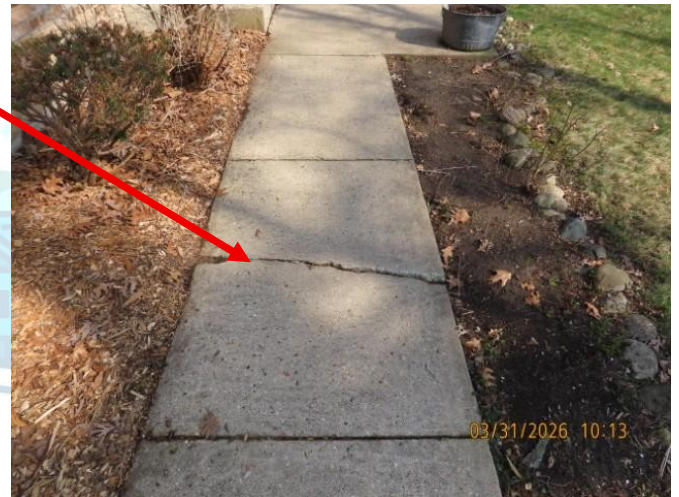
- **Repair:** The walkway presents a trip hazard. This condition should be altered for improved safety.

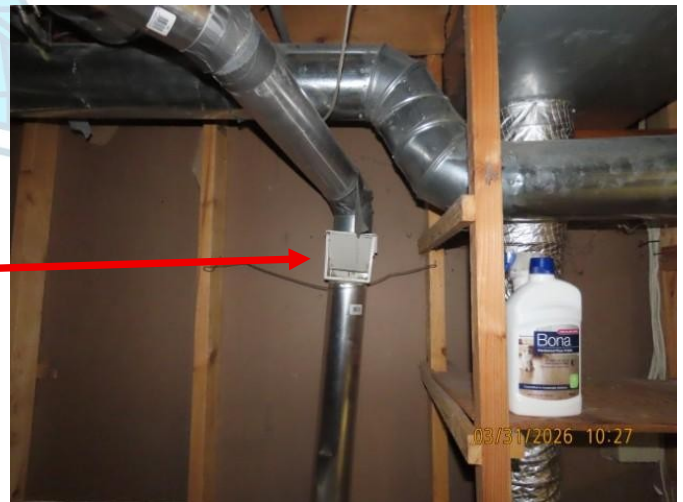
- **Defect:** The clothes dryer exhaust vent pipe (duct) must be improved. Recommend replacing the flex piping with rigid metal pipe. The dryer vents into the basement. This puts humidity into the home and promotes mold and mildew. (Appliances)

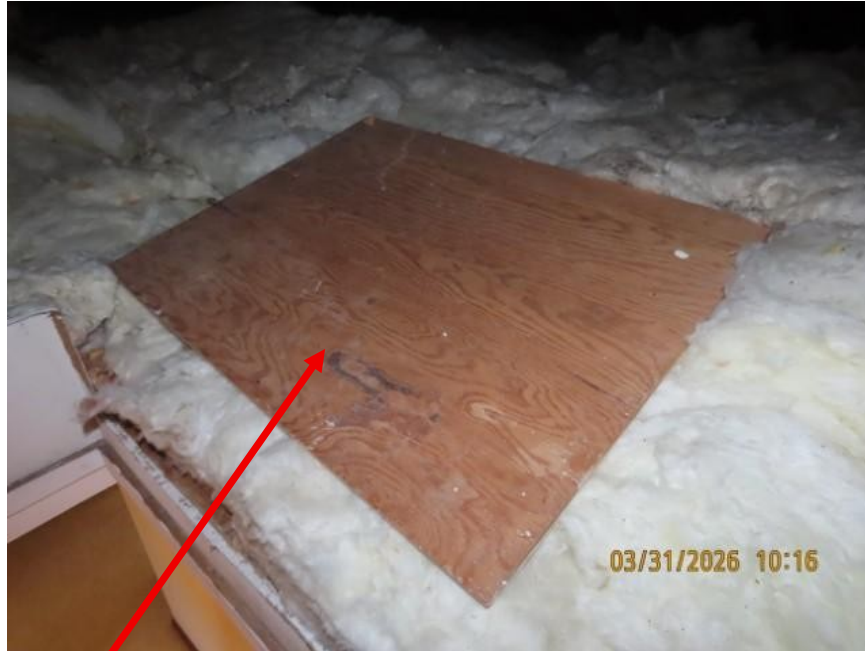
The attic hatch should be insulated and weather stripped

- **Repair:** For improved energy savings, the attic access door should be insulated and weather stripped.

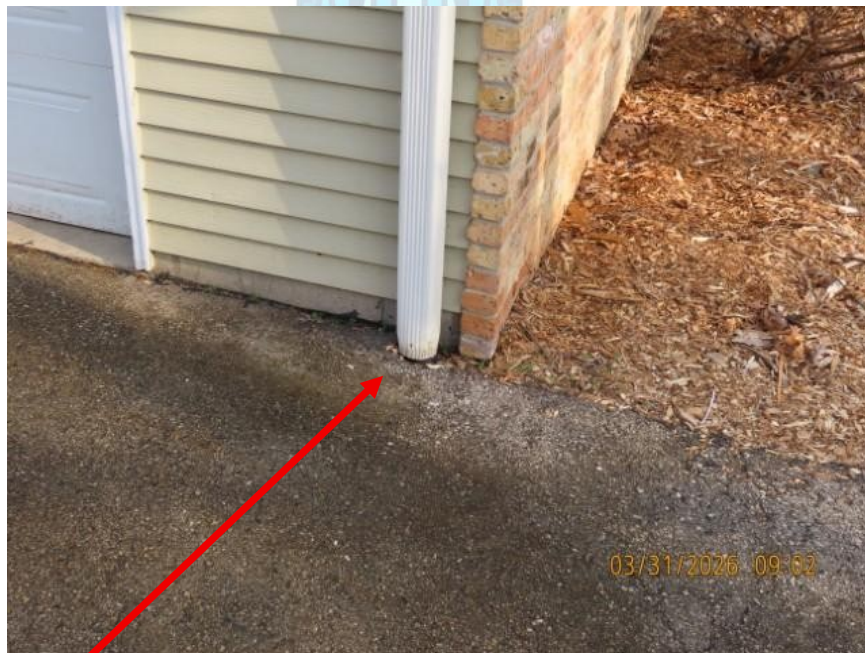
The discharge and location of this extension should be tested

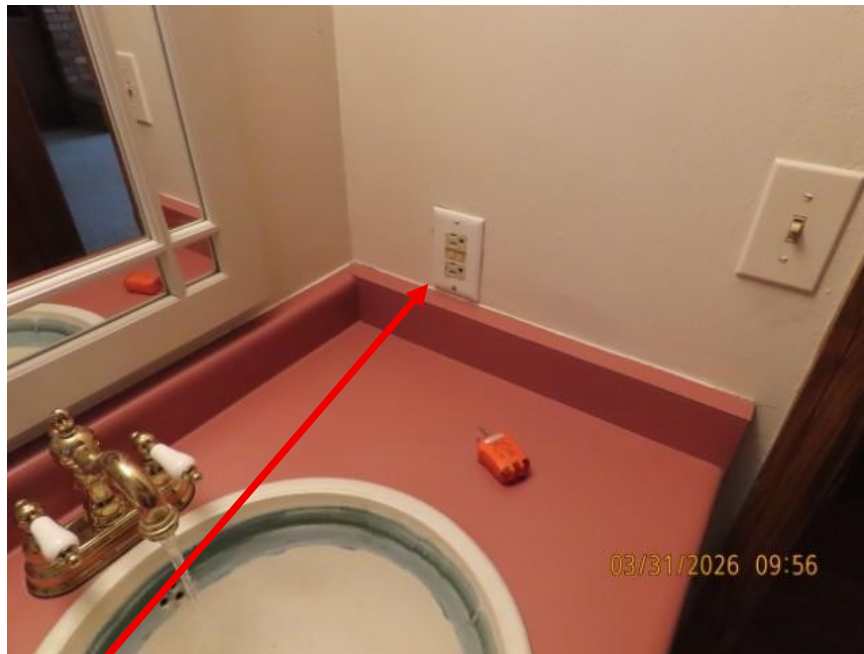
- **Defect:** The ground fault circuit interrupter (GFCI) outlet in the first floor bath did not respond correctly to testing during the inspection. This receptacle should be replaced. The bath fan in the shower cavity also needs GFCI protection. (Electrical)

The first floor bathroom GFCI did not trip upon testing

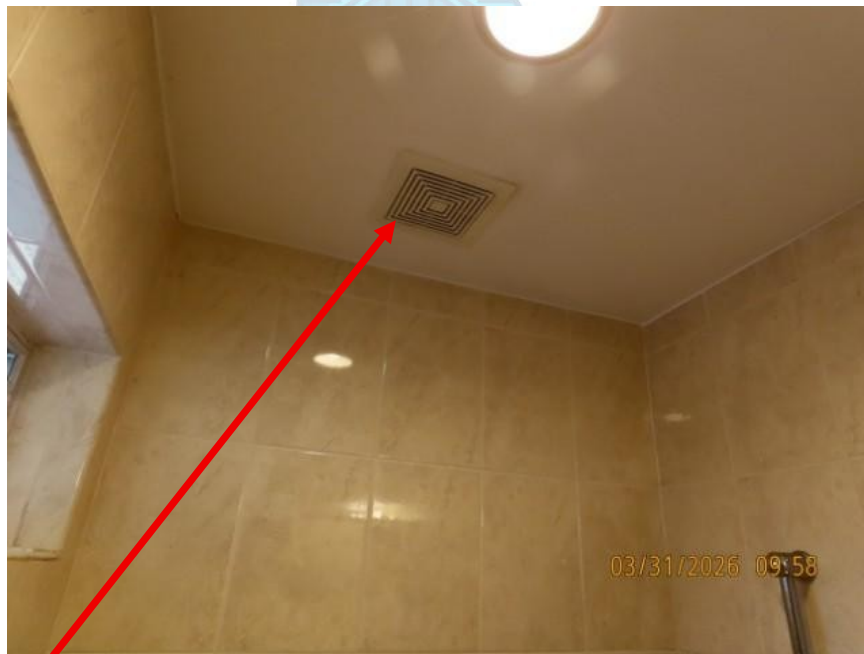
bath fans within the shower cavities must be protected by a GFCI

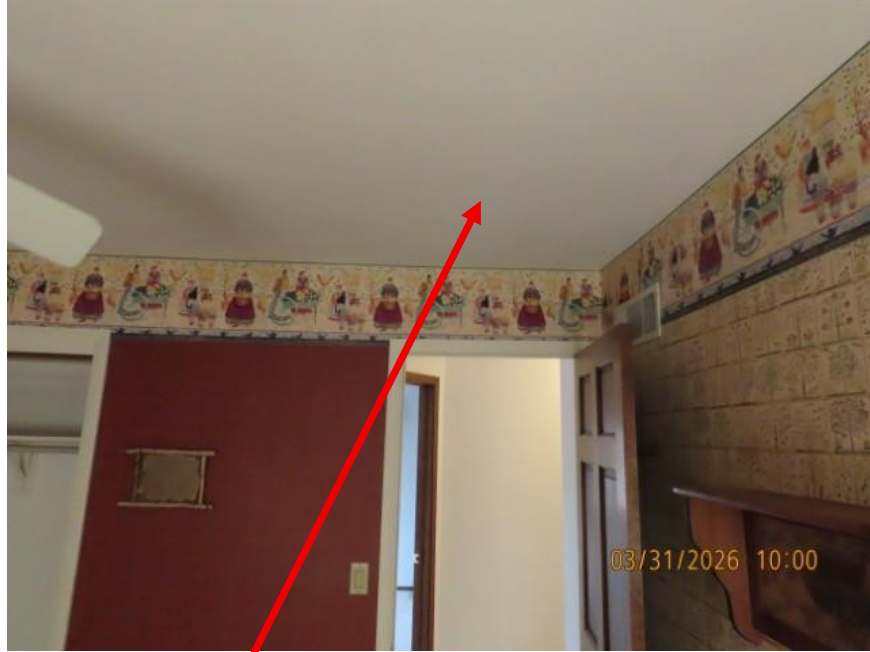
bedrooms need smoke detectors

- **Repair:** The installation of smoke detectors in each bedroom and outside sleeping areas is recommended.
- **Repair:** Carbon monoxide meters are required on all floors including the basement, as of Feb. 2012.

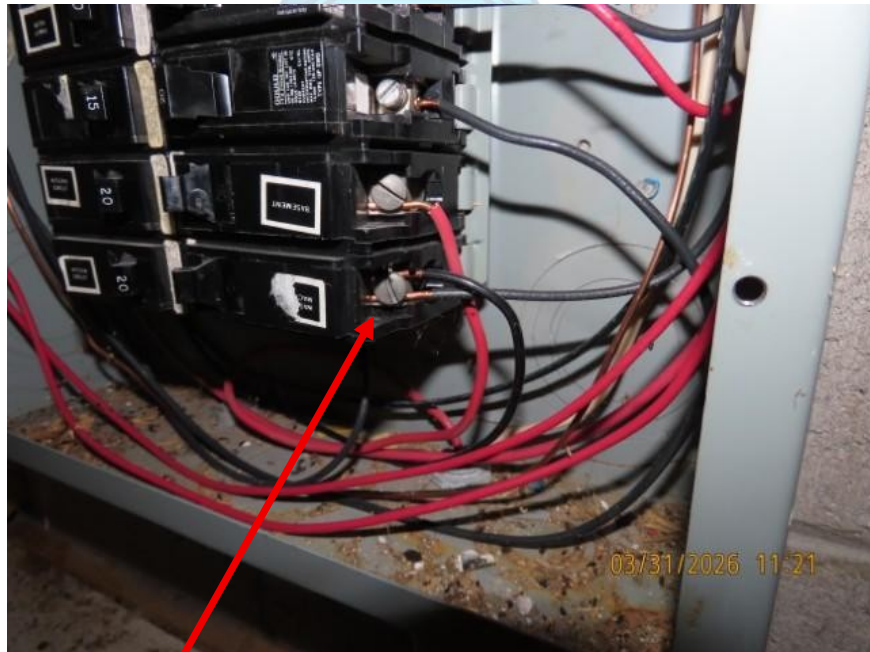
separated. Each circuit should be served by a separate fuse or breaker. This includes the neutral bus bar. Recommend consulting with an electrician and repair as needed.(Electrical)

double taps in the auxiliary panel need repair
