Building Inspection Report

2231 W Wendle Lane St Marcus, WI 53207

6/4/2023

Highland Home Inspections LLC

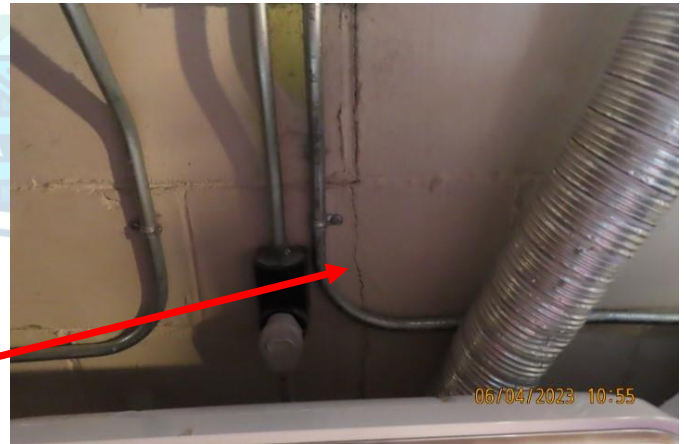
- **Monitor:** The **South** wall is **3/4 inch** out of plumb. Corrections to the gutters, grading and downspouts should be done to remove excess moisture from the ground within 5' of the foundation. If further movement occurs to the foundation a Structural Engineer should be consulted.
- **Monitor:** Larger than typical foundation settlement cracking was observed. The amount of movement which has occurred is not likely to have caused other damage to the structure but this area should be monitored. If additional movement occurs, more costly repairs might be necessary. The rate of movement cannot be predicted during a one-time inspection. These cracks may need sealing on the exterior to prevent moisture penetration.

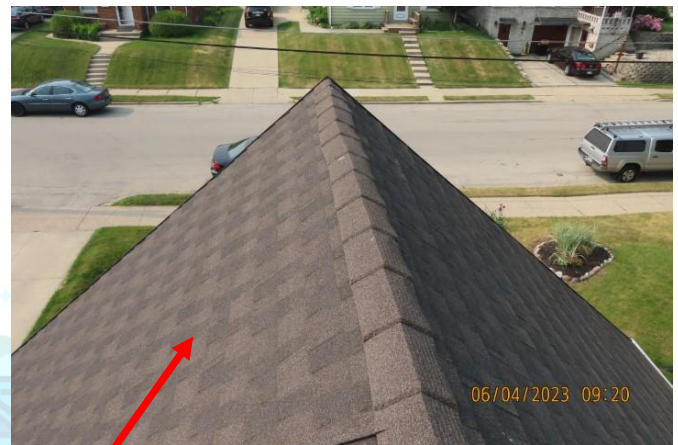
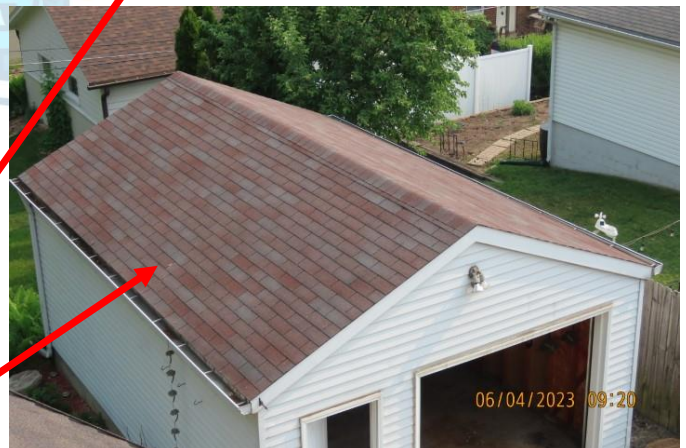
- **Monitor:** The house sloped roofing is newer and in good condition.
- **Monitor:** The garage sloped roofing is in fair condition. We did not see evidence of active leaks nor need for immediate major repair.
- It is recommended that the present layers of roofing materials be removed prior to re-roofing. This adds cost to the demolition and debris removal.
- The south and west sides of a roof typically wear faster than the other exposures of the roof. If the best roof sections have less than five years of life remaining while the worst sections are already in need of replacement, it is usually logical to replace all roof slopes during re-roofing.

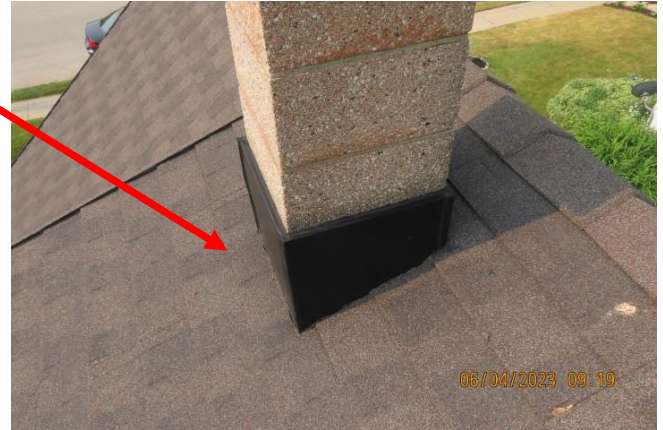
- **Major Concern, Repair: Defect:** The installation of the chimney, bath fan vent, plumbing stack, front vestibule, and dormer flashings are incomplete and must be repaired to avoid leaks. It's possible that a warranty claim may be possible if made by the present owner who had the roof installed. The roof should be examined by a roofing contractor and repair/replacement cost estimated. (Roofing)

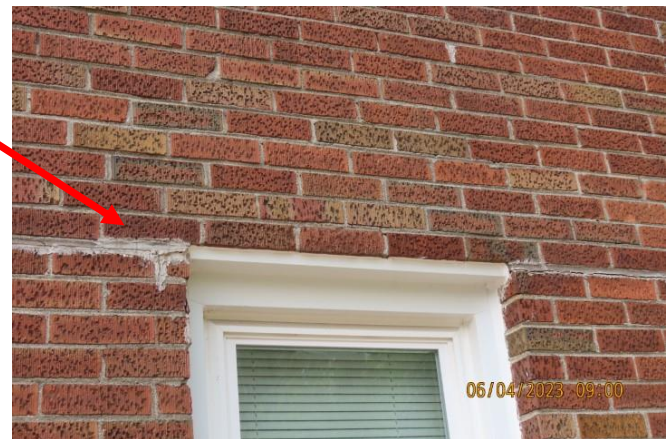
- **Repair: Defect:** Exterior wall cracks above lintel (a lintel is a beam supporting masonry above an opening in a wall) at the north exterior suggests that the lintel has failed. This condition is not uncommon. The lintels should be replaced by a mason. (Structure)
- **Monitor:** Exterior wall cracks above a lintel (a lintel is a beam supporting masonry above an opening in a wall) suggests that the lintel may be marginal. This condition is not uncommon. If additional movement occurs repairs will be needed. The lintels should be painted with a rust inhibiting product to prevent further cracks and movement.
- **Repair:** The lintels (a lintel is a beam supporting masonry above an opening in a wall) have been caulked and this will allow water to buildup in the wall. The caulk should be removed so that water can drain out above the window and also preserve the lintels.

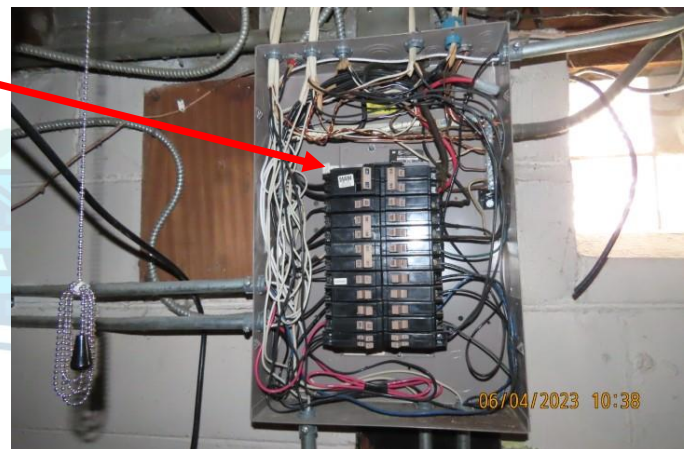
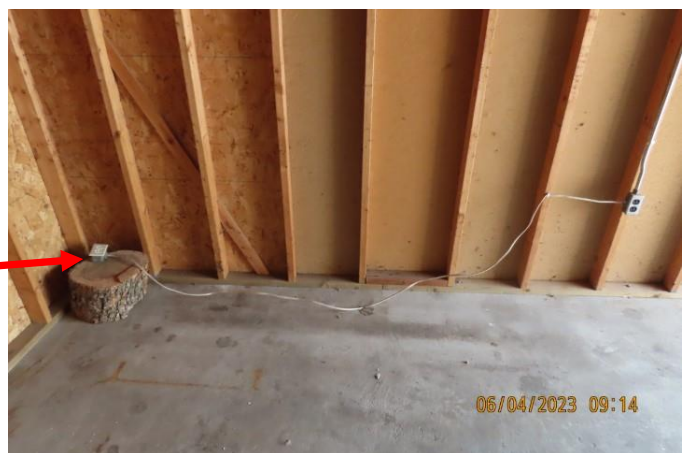
- **Repair:** Loose wiring should be secured.
- **Repair:** Wiring exposed on interior finishes should be relocated or protected by a rigid conduit.

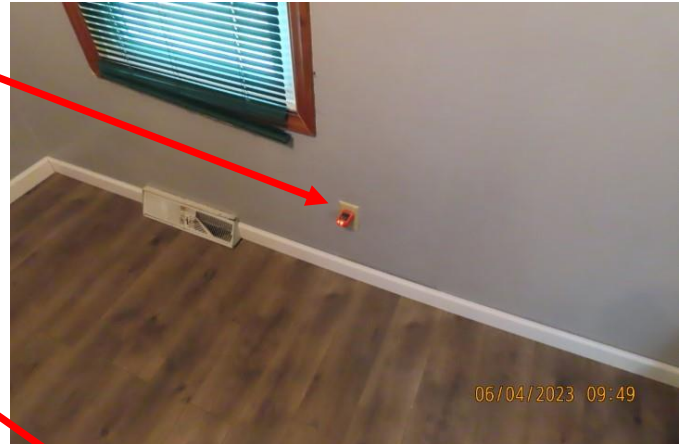
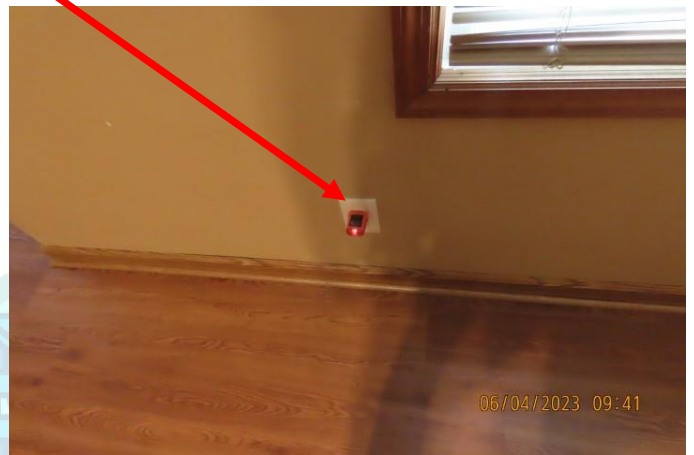
- **Repair:** Outlets that are loose should be repaired.
- **Safety Issue: Defect:** The ground fault circuit interrupter (GFCI) outlet in the garage did not respond correctly to testing during the inspection. This receptacle should be replaced.(Electrical)

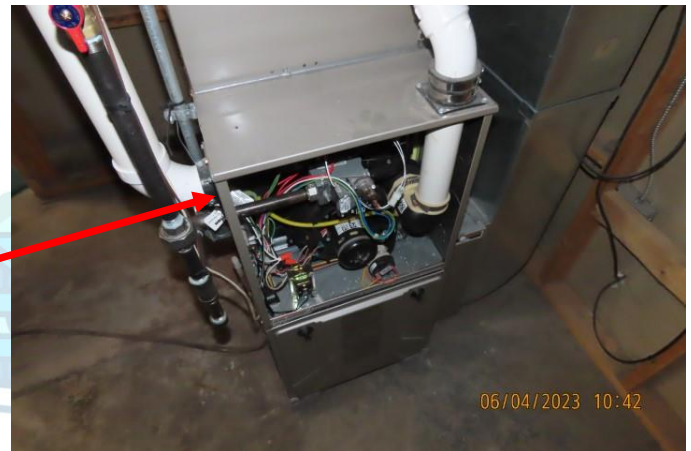
- The heating system was tested for CO with a Testo - 325 CO meter and the level was 19ppm. For most furnaces and boilers 80 PPM or lower is considered normal operating condition. CO levels over 100 are a safety issue and should be evaluated by an HVAC contractor.
- The furnace was tested and functioned properly at the inspection. A temperature rise test was performed and the temperature rise was within the normal range. A temperature rise test is the temperature difference between the supply air and the return temp at the plenum.
- **Repair:** The heating system requires service. There were no service stickers on the furnace unit that indicate this unit has been serviced in the past two years. This should be a regular maintenance item to assure safe, reliable heat. Recommend further evaluation by a licensed HVAC technician.

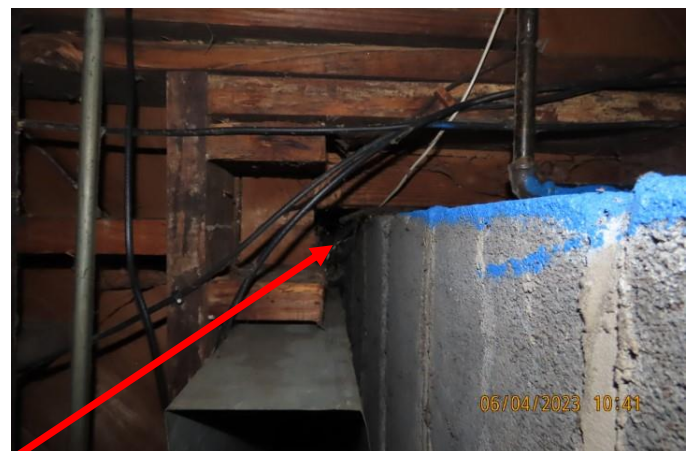
- **Repair:** Balancing of the ductwork is recommended to improve the distribution of heat supply.
- **Improve:** Duct cleaning is recommended.

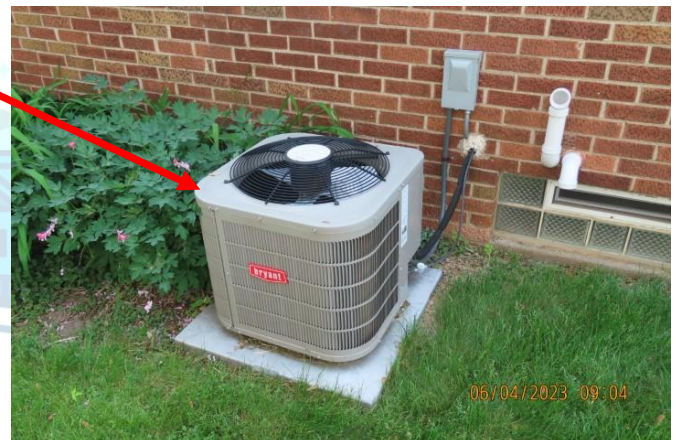
- The AC cooling differential was 21°. The differential should be between 14°to 21° for a normal operating AC unit.
- **Repair:** The air conditioning system requires servicing. There were no service stickers on the AC unit that indicate this unit has been serviced in the past two years.

Installing additional return air vents would help to improve the distribution of cool air within the home.

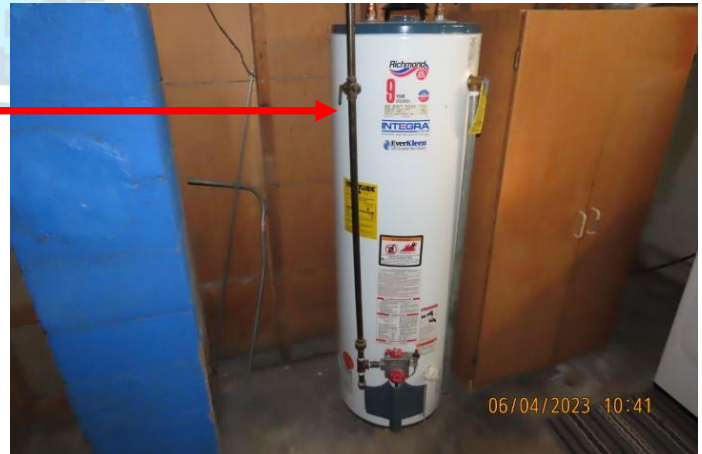
- **Deferred Cost Item:** The water heater is an old unit that may be approaching the end of its useful life. It would be wise to budget for a new unit. One cannot predict with certainty when replacement will become necessary.
- **Improve:** It is recommended that when this water heater needs replacement a high efficient power vent water heater be installed. These water heaters are 30% more efficient than standard water heaters and there is less of a chance of CO poisoning.

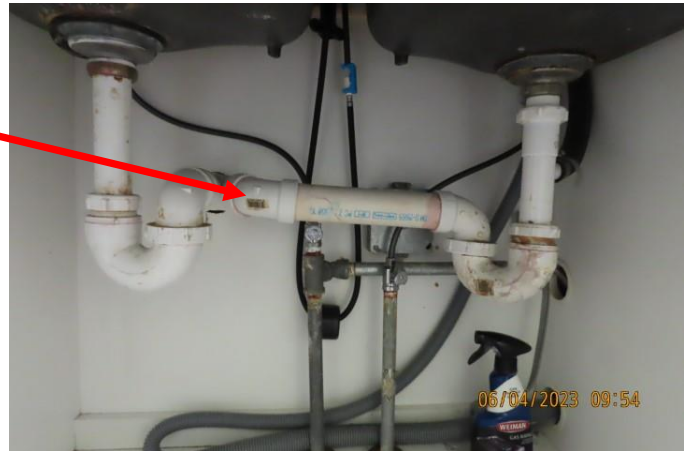
- **Monitor:** For the most part, the waste piping is old. It may be prone to unexpected problems. Improvement is recommended on an as needed basis.
- **Repair:** The waste piping below the kitchen sink does not have sufficient slope for proper drainage.

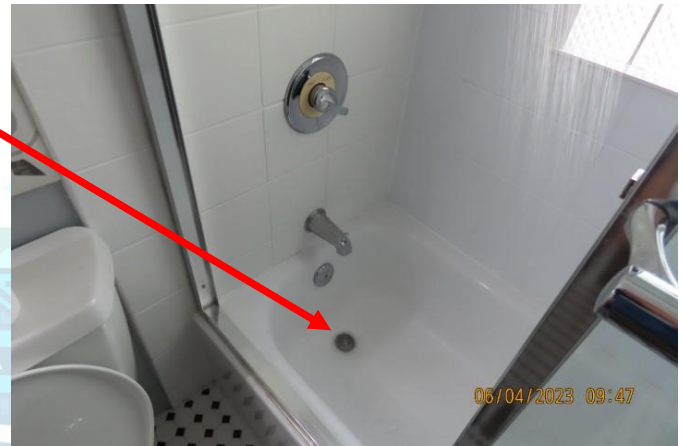
- **Monitor:** The old concrete laundry tub appears serviceable; however, it should be monitored for leakage.
- **Repair:** It is recommended that an anti-siphon device be added to the hose bib(s). The anti-siphon device serves to prevent chemicals from getting into the house water supply when mixing chemicals for exterior landscaping. Please visit <http://www.berryhilldrip.com/Backflow.htm>
- **Repair:** The tub drain stopper does not function.
- **Improve:** The shower diverter no longer functions efficiently. As this condition effects water pressure sent to the shower head, improvement should be undertaken when showerhead water pressure is deemed too low.
- **Improve:** The faucet in the basement bathroom is loose.

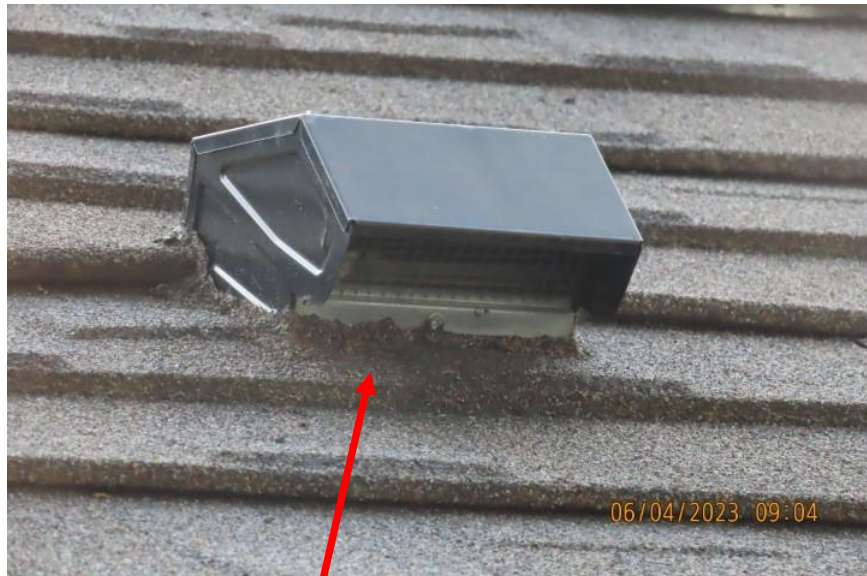
Flashing is incomplete

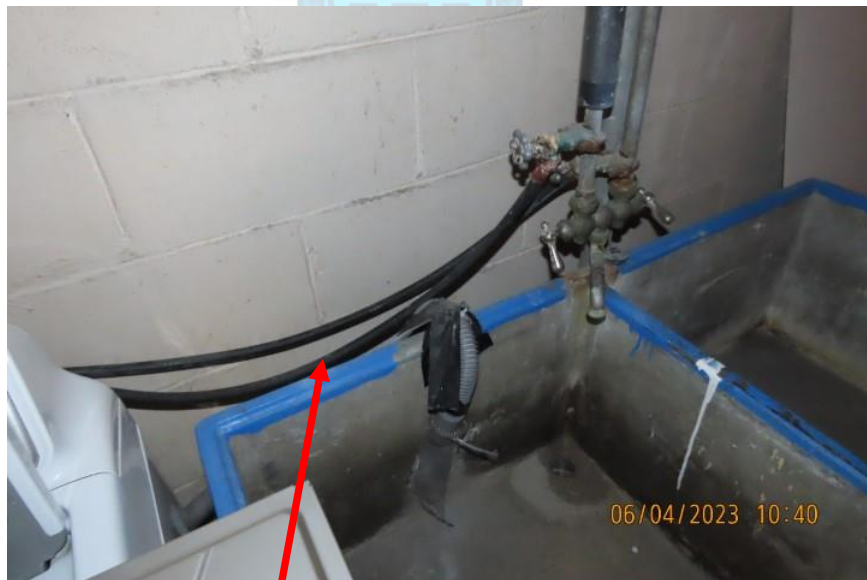
Black rubber hoses have a low psi strength

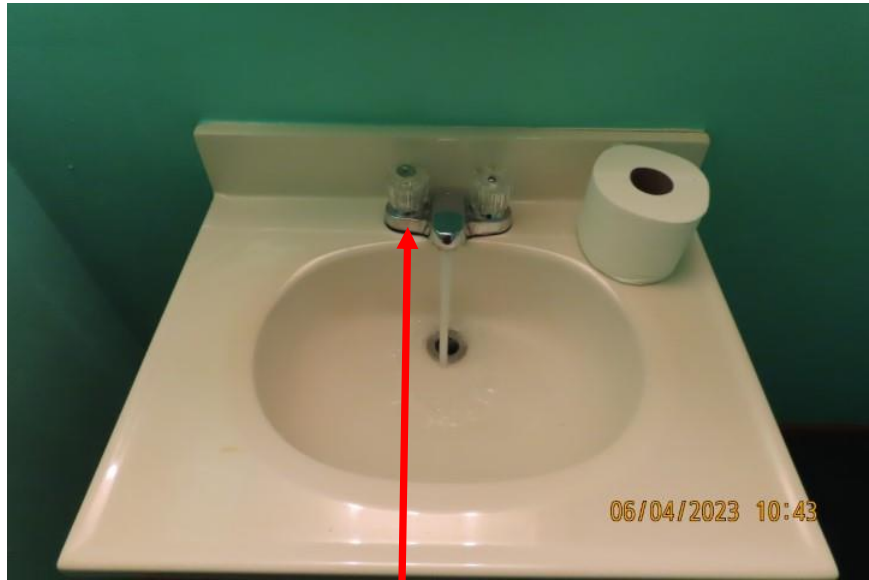
Loose

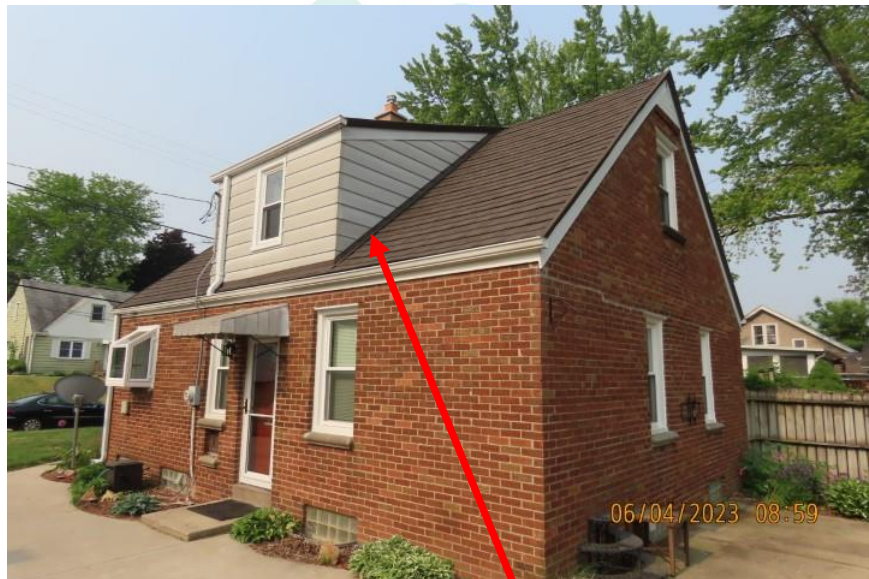
Flashings are incomplete

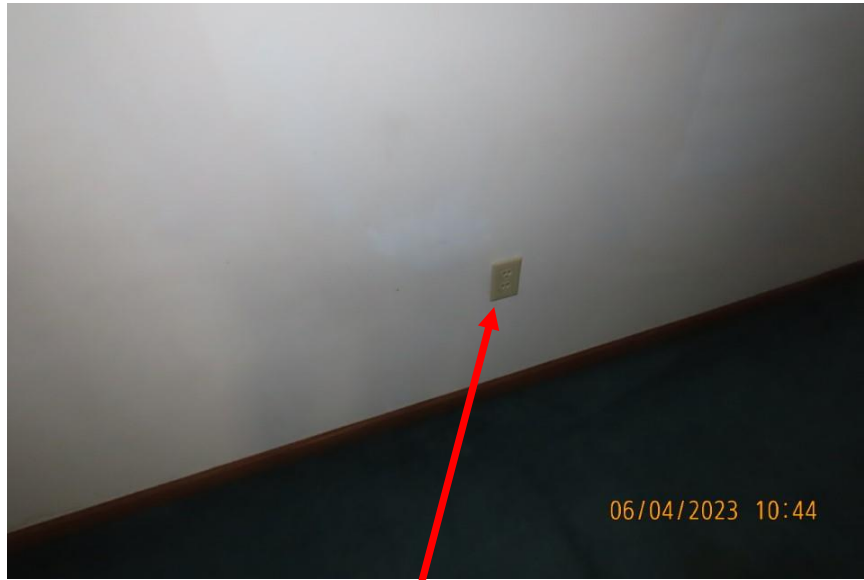
Loose outlets need to be secured

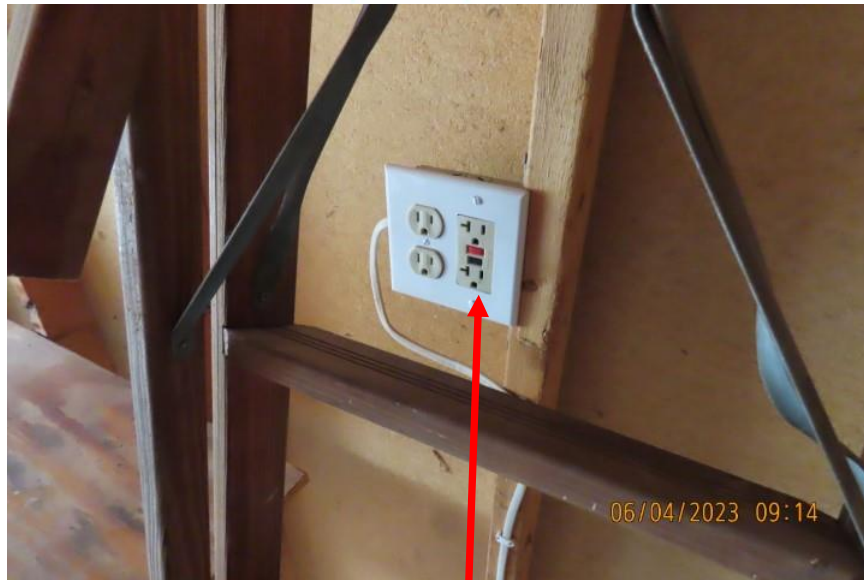
GFCI tested faulty

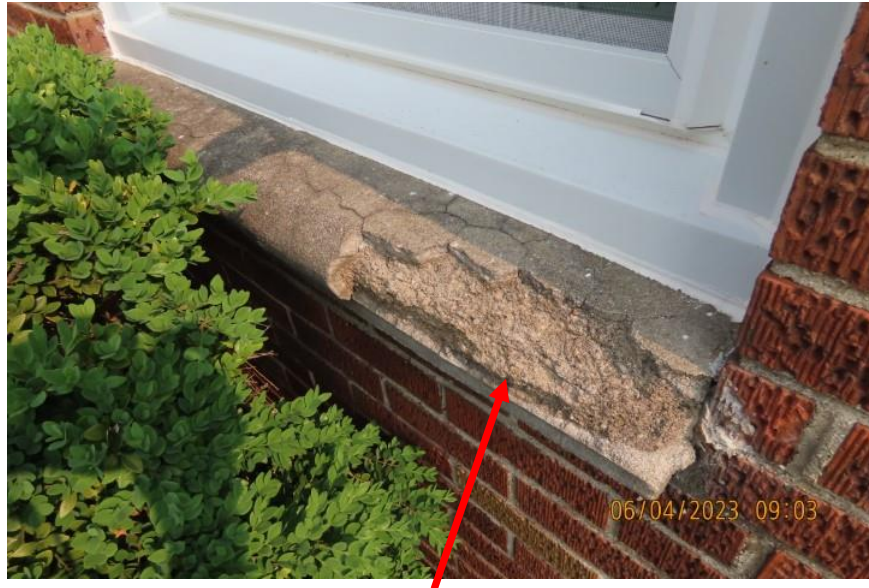
Concrete sills need repair
