# Building Inspection Report

2150 N Cormack Dr Brookfield, WI 53005

3/3/2025

CS500126

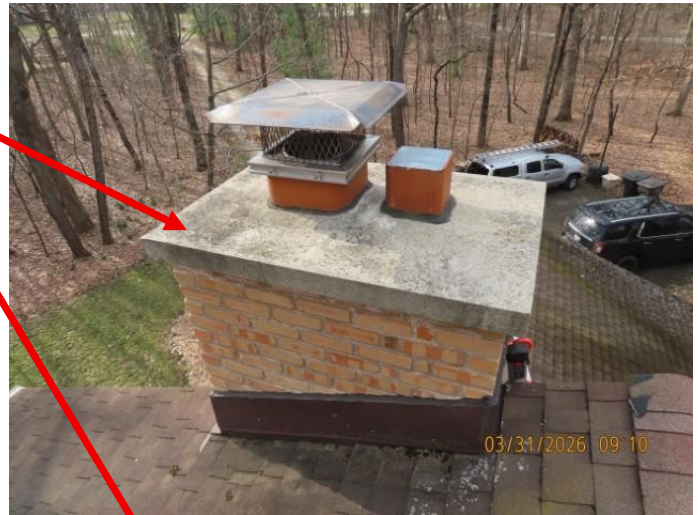
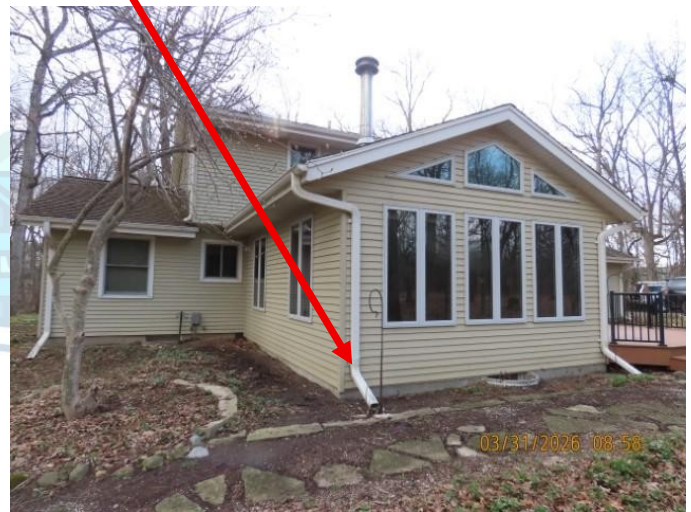
- **Defect:** The downspout(s) should discharge water at least five (5) feet from the house. Storm water should be encouraged to flow away from the building at the point of discharge. (Roofing)

- **Repair:** Corrugated plastic extensions are a poor system for water control around homes and garages. Often water freezes in the corrugations and cracks the bottom of the pipe. Because they follow the contour of the ground they are often improperly pitched. Recommend replacing these extensions with a rigid material.

- **Repair:** Downspout(s) that discharge onto the roof should be extended to discharge directly into the gutters below. This condition, if left unattended, can result in premature deterioration of the roofing under the end of the downspout.

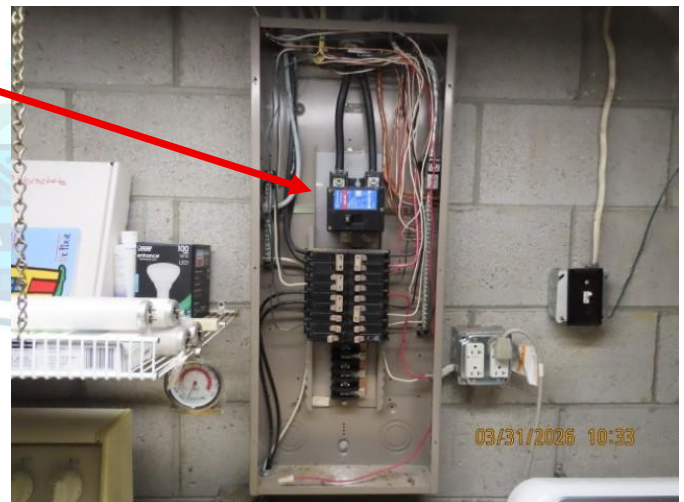
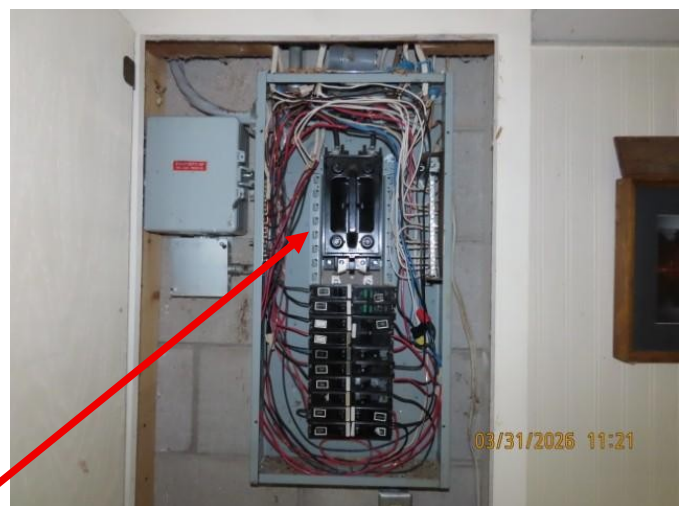
- **Further Evaluation:** The auxiliary panel has a fused main and is thus obsolete and should be replaced. Recommend further evaluation by a licensed electrician.
- **Defect:** Circuits within the auxiliary panel that are doubled up (referred to as "double taps") should be

separated. Each circuit should be served by a separate fuse or breaker. This includes the neutral bus bar. Recommend consulting with an electrician and repair as needed.(Electrical)

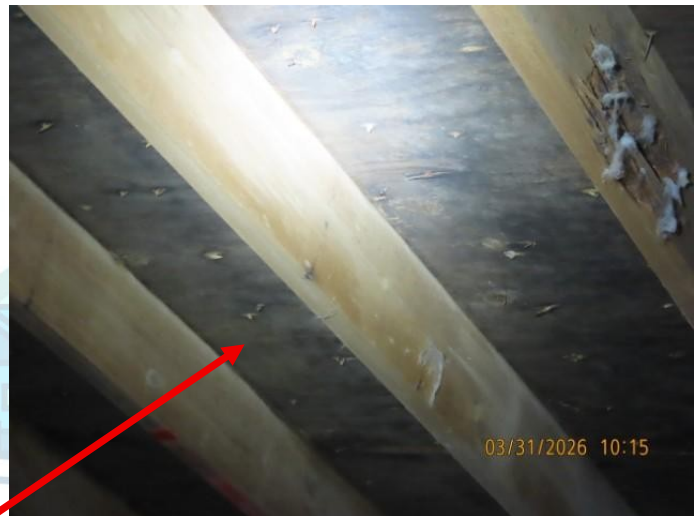
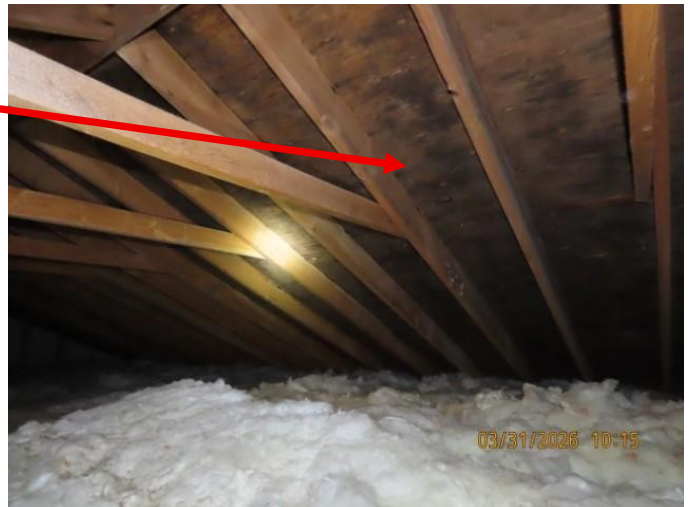
- **Defect:** Exhaust vent pipes from the bathroom(s) must be vented to the building exterior. This can lead to condensation, mold, and mildew. (Insulation)

- **Repair:** For improved energy savings, the attic access door should be insulated and weather stripped.

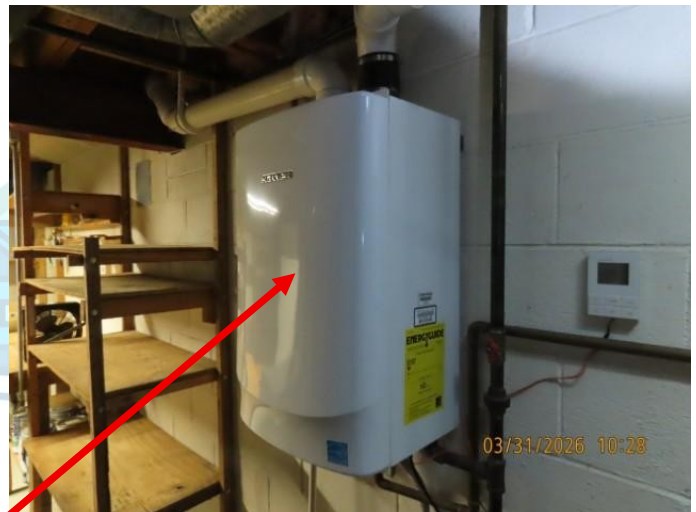
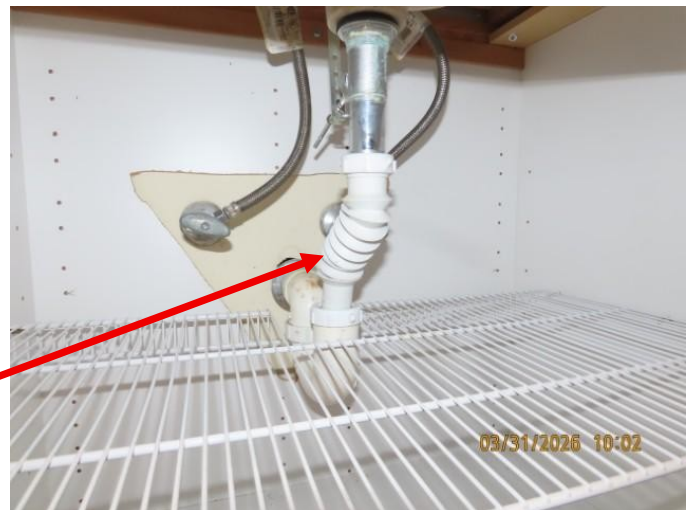
- **Repair:** The installation of the waste piping in the second floor is not workmanlike. Flex waste piping is not a proper plumbing component. A plumbing contractor should evaluate.

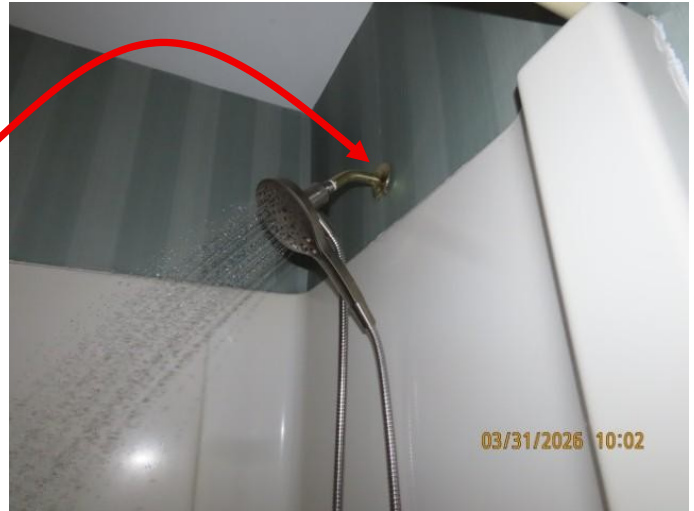
- **Repair:** The shower head in the main floor bathroom is leaky.
- **Repair:** The supply piping for the shower arm lacks adequate support within the wall cavity, recommend a plumber to secure the pipe to reduce the likely hood of metal fatigue.
- **Repair:** The tub drain stopper does not function .
